FATIGUE BEHAVIOUR OF A ROLLED AZ31 MAGNESIUM ALLOYS PREPARED BY EP AND BB CONDITIONS

Abstract: Rotating bending fatigue tests have been performed using smooth specimens of a rolled AZ31 magnesium alloy in laboratory air at ambient temperature. Fatigue strength and characteristic was evaluated and fracture mechanism was discussed on the basis fracture surface analysis. Electrical polishing (EP) as well as deep rolling (ball burnishing (BB)) U-notched specimens were performed on two groups of samples, to evaluate optimum conditions for fatigue life. The microstructure and tensile properties of roll cast (RC) Mg- 3% Al- 1% Zn (AZ31) was investigated. The fatigue strength of 107 cycles around 100 MPa for deep rolling while it was around 40 MPa for Electrical polishing. It was very important to understand the effect of (ball burnishing (BB)) conditions on the hardness of the surface through to the core. The two procedures improved the fatigue performance, but better improve in results were found in ball burnishing. The growth of small cracks initiated at the surface coincided with the FCP characteristic after allowing for crack closure for large cracks, but the operative fracture mecha

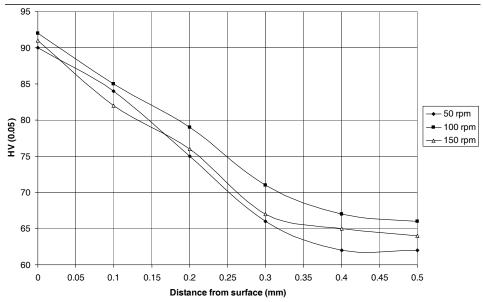
Fig. 3. Microhardness profile oif AZ31 after BB at 200 bars, 0.17 mm/min at different BB rotation speed.

3. 3. A different experiment were used to investigate the best condition for BB (pressure, feed rate, speed) as example for tool HG3 200 bar (123 N) for 50, 100 and 150 rpm. The microhardness measurement from the surface in Fig. 3. Shows that the suitable condition for using 200 bars is 100 rpm for AZ31 as the hardness decreased from the circumference gradually to the center.

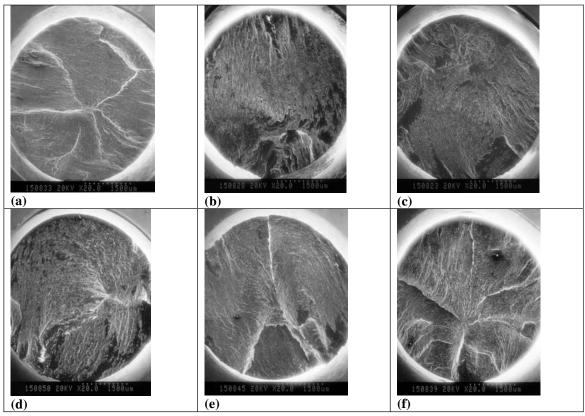
Fig.4. SEM micrographs showing fracture surfaces at difference stress for EP at (a) 60MPa; (b) 80 MPa; (c) 100 MPa and BB at (d) 60MPa; (e) 80 MPa; (f) 100 MPa.

The fracture surface of AZ31 for EP condition and BB condition at different stress is shown in Fig.

4. Subsurface crack initiation occurred at applied stresses at 60 MPa. At BB condition but it can be seen for both 80 and 100 MPa stress for EP condition. The S–N diagram is shown in Fig. 2. It is well known that fatigue limit does not exist in non-ferrous alloys, thus fatigue tests were continued until 10^7 cycles. At EP condition σ = 40 MPa, fatigue failure did not occur, but non-propagating cracks were observed on the specimen surface. As can be seen in the figure, the present Mg alloy seems to possess a definite fatigue limit, which may be related to the existence of non-propagating cracks. The fracture mode depending

on applied stress level, above 60 MPa cracks initiate at the surface (surface fracture), while below that stress at the interior of the specimen (subsurface fracture). Subsurface fracture is a very interesting finding, which has not been recognized in Mg alloys, for both EP and BB conditions.
